Date: July 9, 2025

RE: Structural Deck Assessment  
[REDACTED], Bourbon, MO 65441

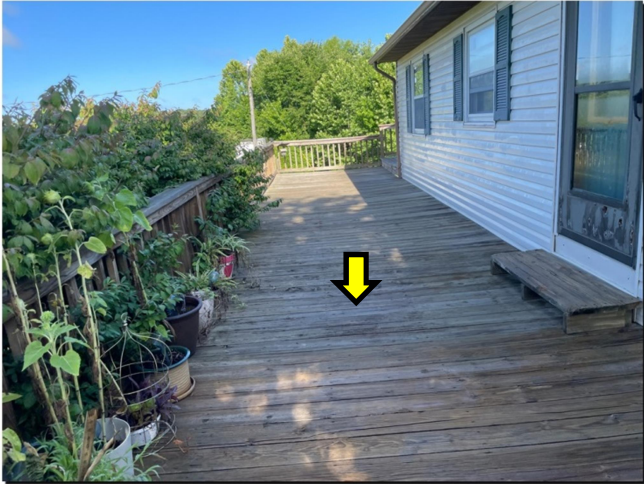
Photo 1 – Deck surface sagging

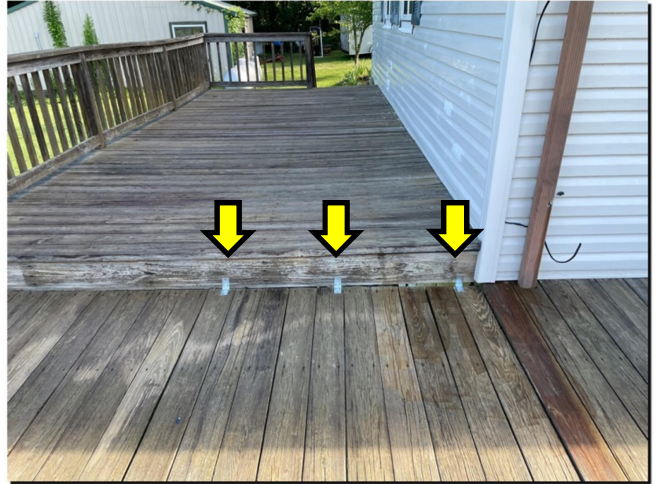
Photo 2 – Recent attempt to repair

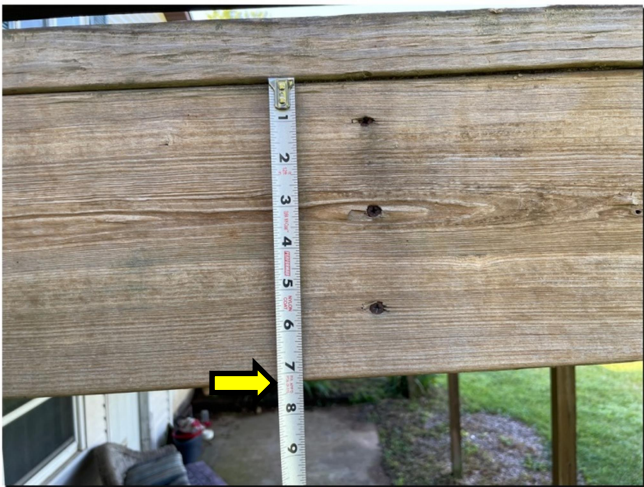
Photo 3 – All support structure 2x8 lumber

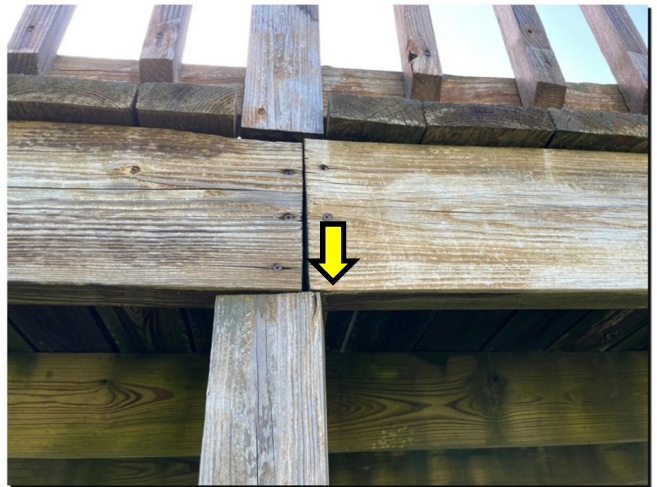
Photo 4 – Inadequate beam support

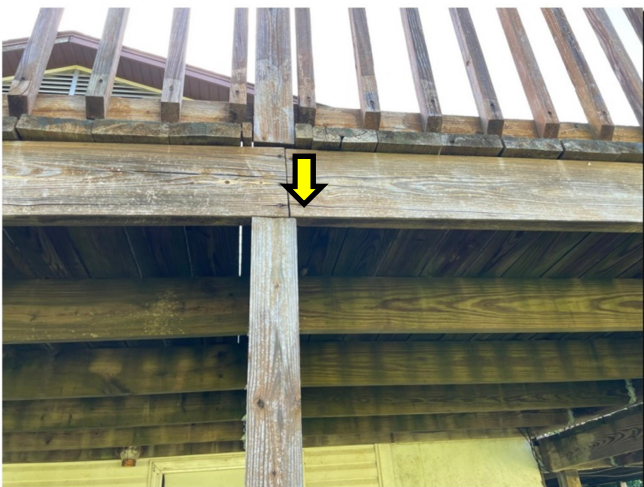
Photo 5 – Inadequate beam support

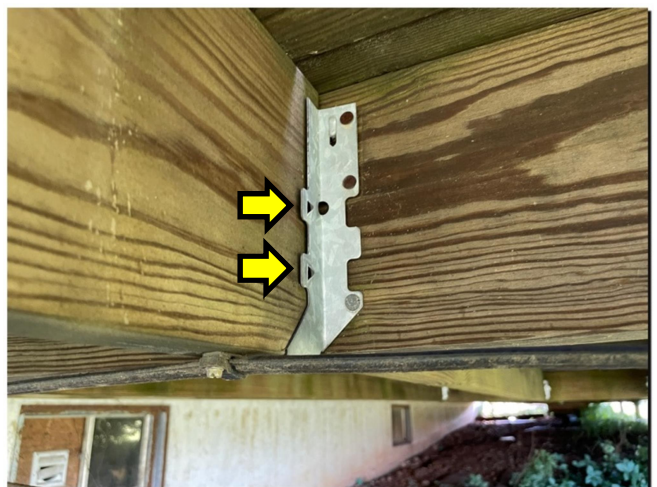
Photo 6 – Missing joist hanger nails

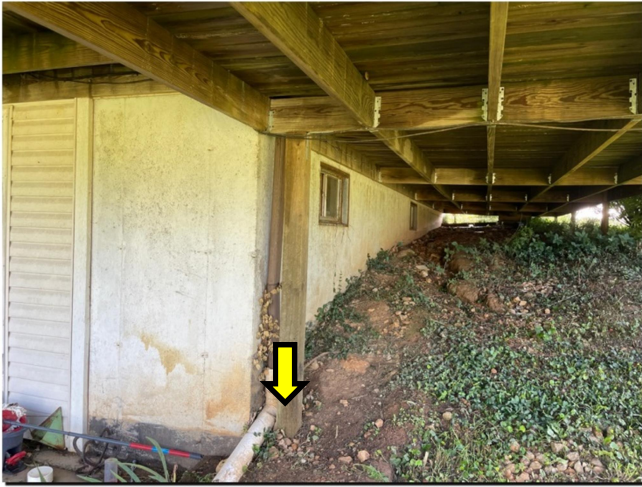
While the 4x4 wooden columns can handle the design loads, the supporting soil is inadequate without proper foundations. Each column would require a 16"x16" concrete footing extending below the frost line (approximately 20-24 inches deep).

Photo 7 – Support post has settled

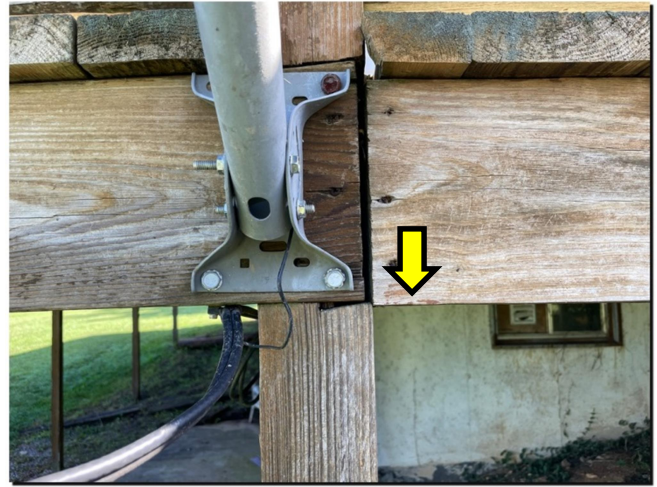
Photo 8 – Inadequate beam support

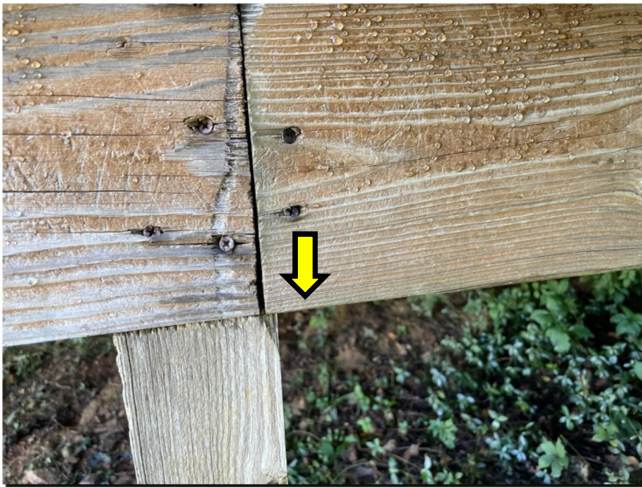
Photo 9 – Inadequate beam support

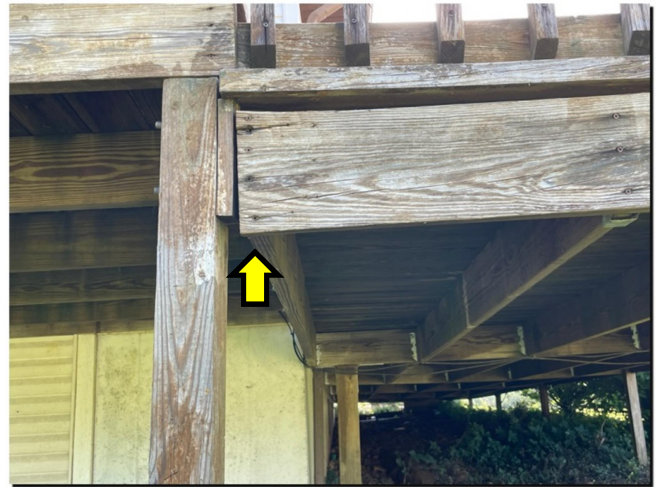
Photo 10 – Inadequate beam support

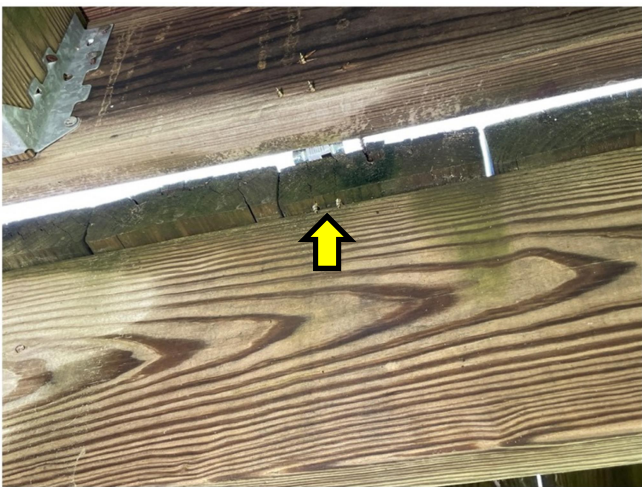
Photo 11 – Weak screw connection

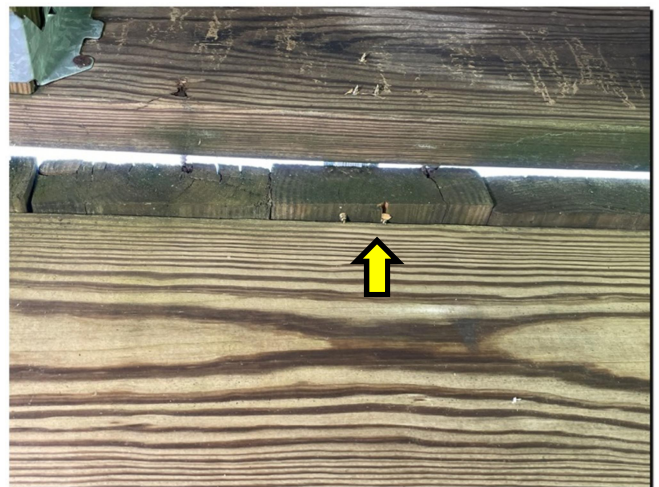
Photo 12 – Weak screw connection
